123 Maple Drive, Cincinnati, Ohio

Prepared For
Mr. & Mrs. Smith

Inspected On
May 10th, 2004 at 2:00 pm

Summary of Findings

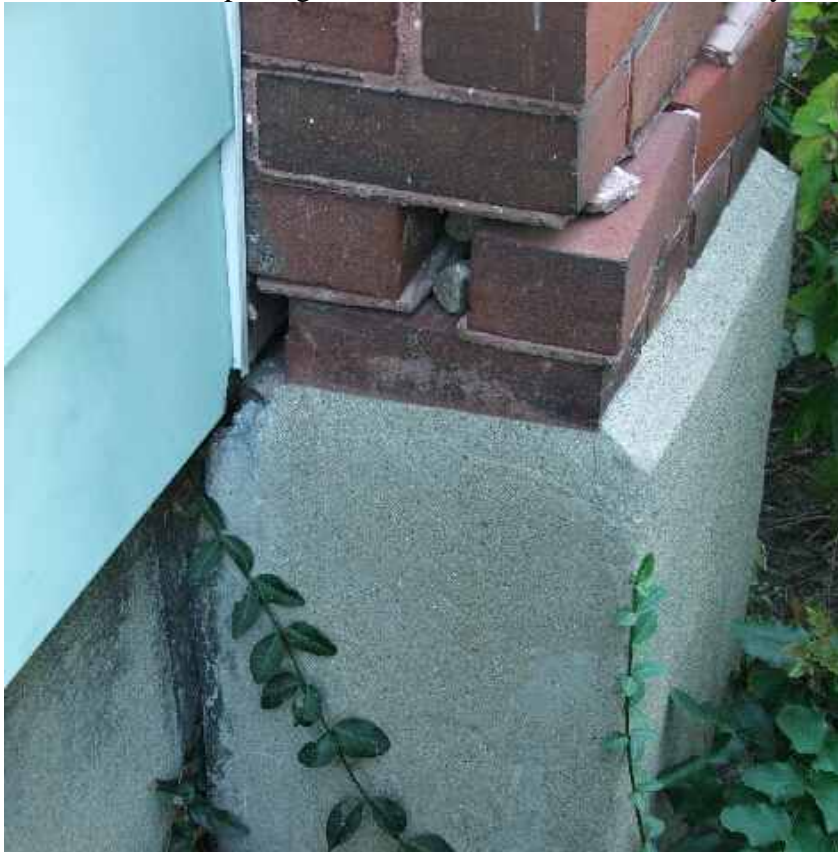
- A) The foundation for the chimney has settled and pulled away from the house. It is no longer supporting the chimney. As a result, the section of the chimney above the roof is leaning away from the house. A qualified mason should be contacted to estimate the cost of repairing both the foundation and the chimney.

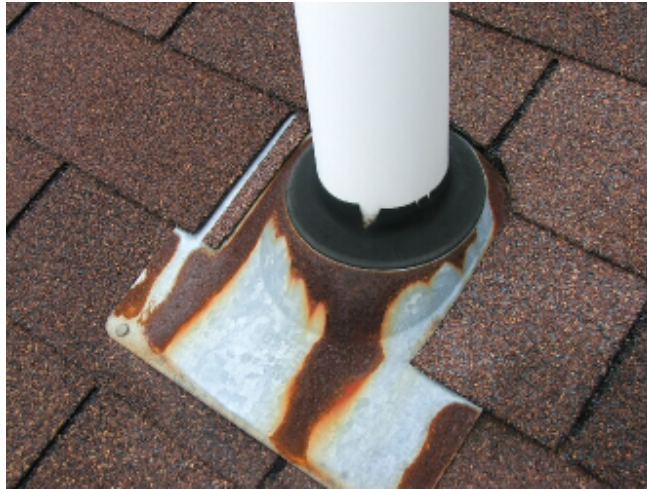
- A) The attic does not have sufficient ventilation, which can cause the roof to prematurely age. The air temperature inside the attic was 140 degrees (over 50 degrees warmer than the outside air).
- B) The boot around the plumbing vent on the South side of the house is split and the flashing is rusted. This needs to be repaired to prevent water penetration into the attic.

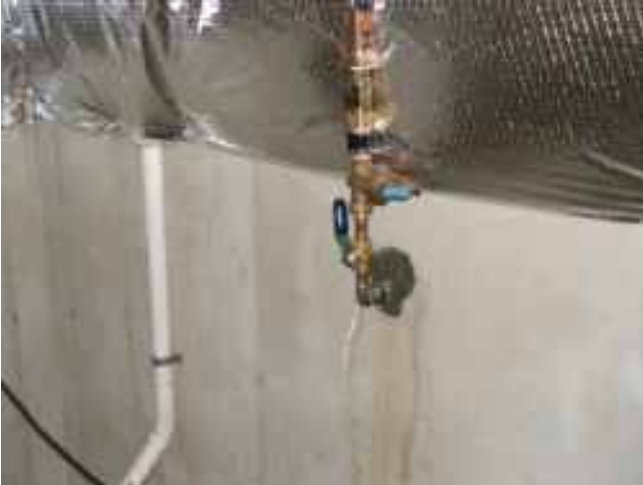
Main Water Shut-off

Water Shut-off:
The main water shut-off is the ball valve located on the North wall of the basement.
